EXAMPLE REAL LIFE FIRES AND EXPLOSIONS

CC	ONTENTS	
Event	Fire Safety	Page
	issue	
Abbeystead	CVCE	2
Albright & Wilson	Toxic Fire	3
Bradford City Football	Fire	6
Fire		
Buncefield	Explosion	7
General foods	Dust explosion	10
Kings Cross Fire	Human failure	11
Piper Alpha	Human Failure	13
Windsor Castle Fire 1992	Fire	19

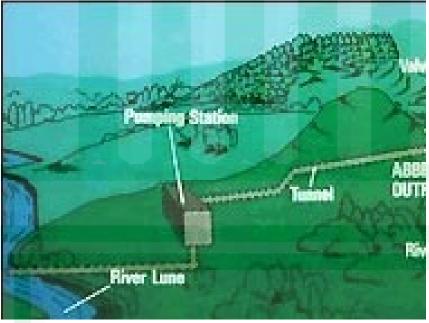
The Lancaster River Authority had commissioned a firm of engineering consultants, Binnie and Partners, to design a system to transfer water from the rivers of the northern part of the country to south Lancashire. The Wyresdale Transfer Scheme was designed in the early 1970s. It was to be the initial stage of a larger scheme and its purpose was to transfer water over a distance of 11.6 km between the River Lune at Lancaster to the River Wyre at Abbeystead.

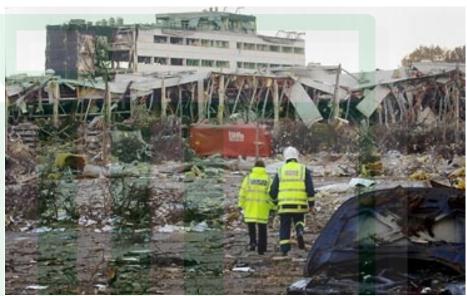
This report describes where and how fuel escaped from storage at the Buncefield Oil Storage Depot on 11 December 2005 and how it vaporised, forming a flammable mixture that subsequently ignited at around 06.00 that morning with devastating consequences. It summarises the work carried out to analyse the electronic records that were recovered from site and experimental work undertaken by the Health and Safety Laboratory

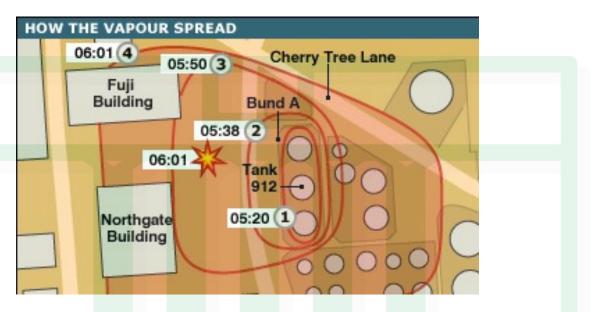
From 05.20 onwards, continued pumping caused fuel to cascade down the side of the tank and through the air, leading to the rapid formation of a rich fuel/air mixture that collected in bund A. At 05.38, CCTV footage shows vapour from escaped fuel start to flow out of the north-west corner of bund A towards the west. The vapour cloud was about 1m deep.

At 05.46, the vapour cloud had thickened to about 2 m deep and was flowing out of bund A in all directions. Between 05.50 and 06.00, the pumping rate down the T/K South pipeline to Version 1 2019 Page
